Case study 011

Turbine runner weld repair

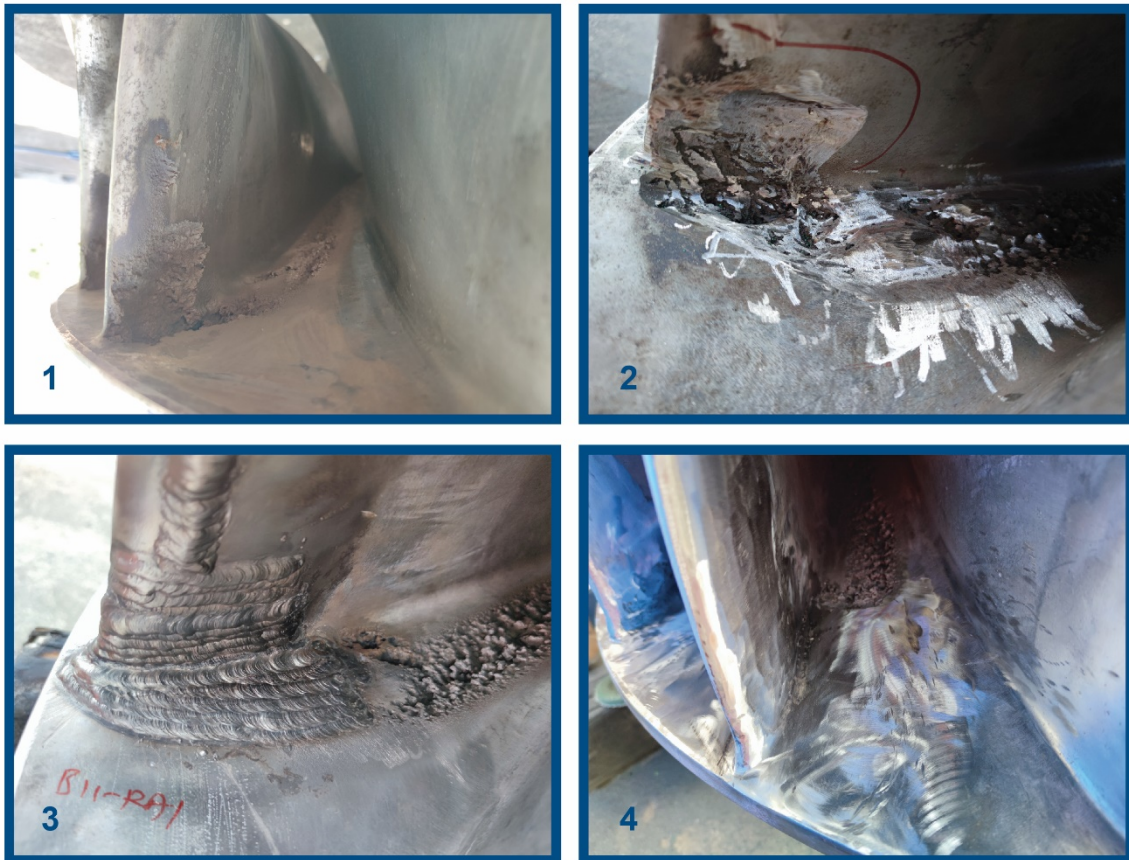
Figure 2 Overview of the outcomes of weld overlay repair process

The repaired runner was from the Unit 4 turbine of the Ramu 1 hydropower plant where it was commissioned in 1983 and constructed from grade GX4CrNi13-4 (equivalent to A/SA-487-CA6NM Class A) martensitic stainless steel. The runner suffered cavitation damage at the shroud and blades. The cavitation was especially severe at the leading edge of the shroud and blade, where severe metal loss occurred on blades and a large volume of cavitation on the shroud with the pit depth ranged between 19mm and 25mm.

Legends: 1 – Cavitation damage; 2 – Ground cavitation; 3 – Completely repaired cavitation; 4 – Ground surface after excess weld metal removal.

The weld repair process from removing cavitated areas until the final grinding of excess weld metal to regain the geometry of the repaired area are illustrated in the Figure 2. The control measures applied to solve the material and distortion challenges are illustrated in the Figure 3.

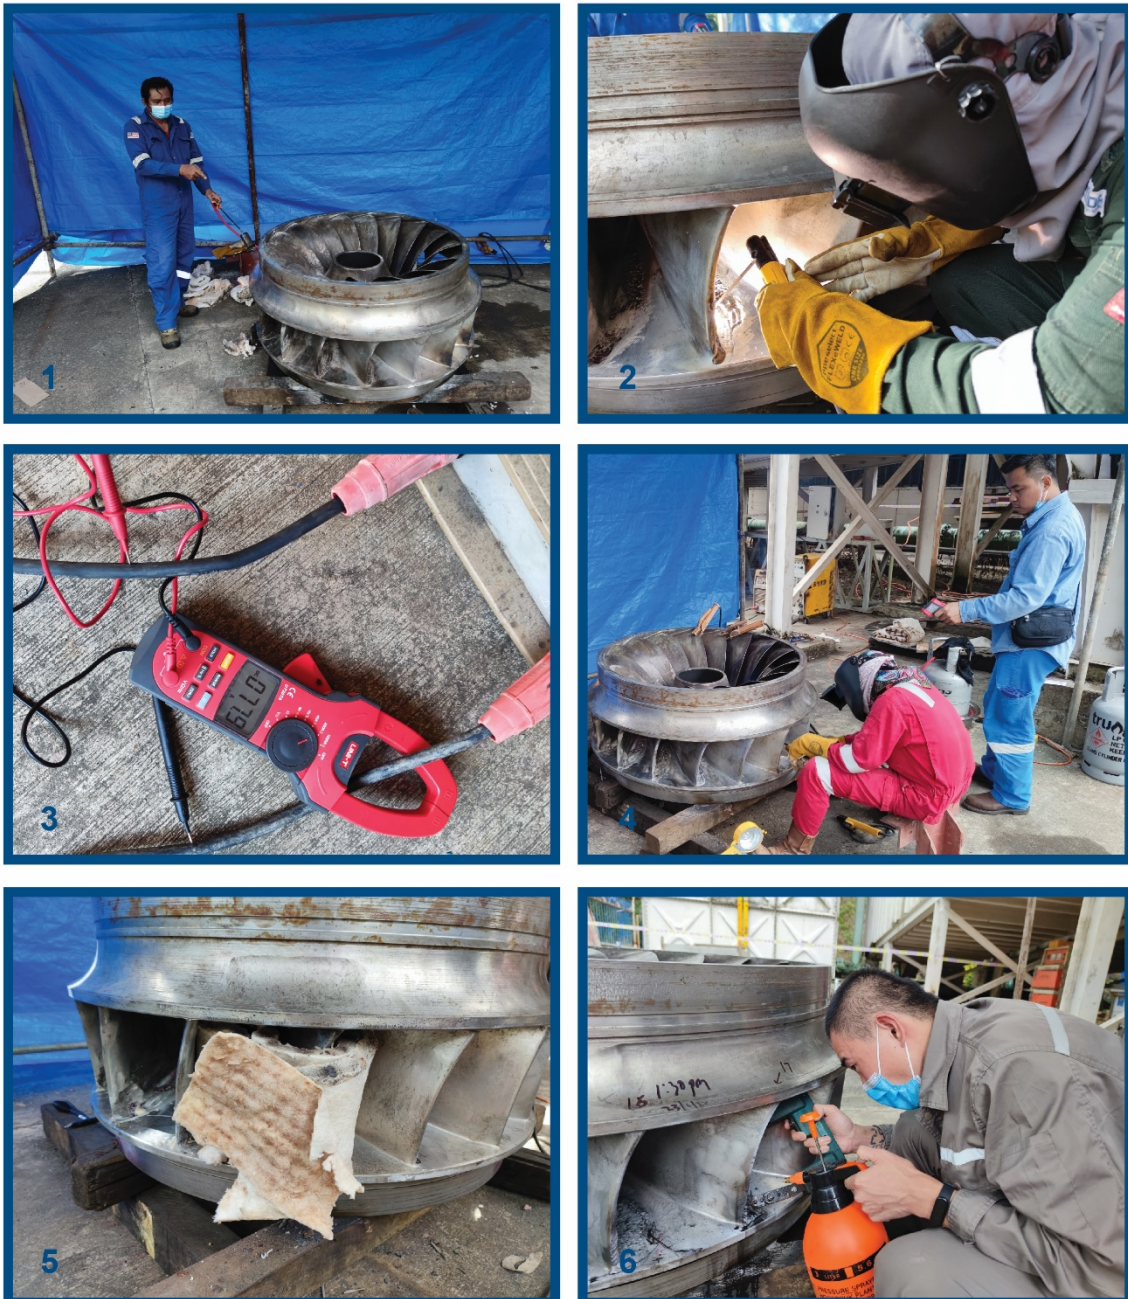
Figure 3 Weld overlay repair process and quality control

Legends: 1 – Preheating; 2 – Welding; 3 – Welding parameter monitoring; 4 – Interpass temperature monitoring; 5 – Slow cooling of weldment; 6 – Magnetic particle inspection.

In the context of avoiding the possibility of cold cracking, high preheat, low heat input and multi-pass welding techniques were adopted.

Control of interpass temperature was taken to avoid excessive surface oxidation and grain coarsening. The interpass temperature was controlled at maximum 200°C to avoid excessive surface oxidation and grain coarsening effect. In the condition when the material surface is over oxidised, the corrosion resistance film on the surface will be damaged and the corrosion resistance will be unrestorable. Control of interpass temperature was also adopted to avoid the material expose to high interpass temperature for a prolong period. If this condition is happened, the grains of the material will be coarsened and resulting reduction of toughness. In order to ensure welding is not performed at the interpass temperature higher than 200°C, the interpass temperature was constantly monitored by a welder helper.
