Case study 012

Welding and quality professions in one: A case for spiral case welding improvement

Edevu hydropower plant is a private invested power plant in Northeast of Port Moresby. The hydropower plant will provide 54MW to the Port Moresby Grid and aims to stabilize the power supply in Port Moresby region. The project is currently in the equipment installation stage and spiral case construction was a critical task for the success completion of the hydropower plant. Spiral case is important due to the complexity during operation and the high integrity requirements to ensure safely and reliable operation. In this context, a shareholder of the plant decided to recruit a welding engineer to assure the quality of the spiral case welding.

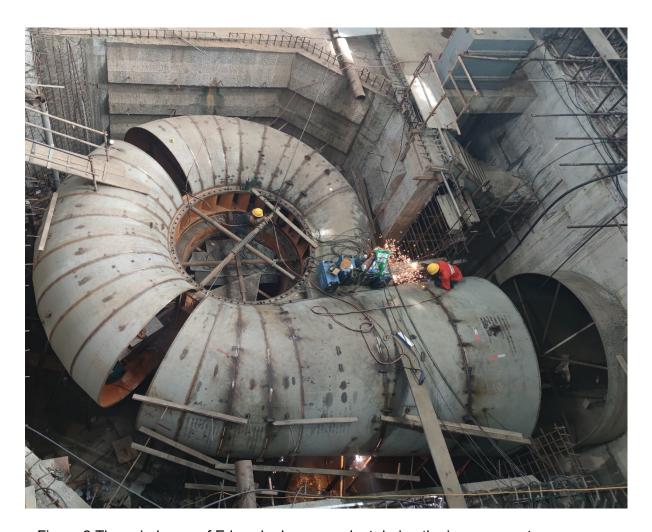
The outcomes of the daily surveillance showed that the welding practice and welder compliance to welding procedure have been improved and no incorrect practice was adopted again. The inspection results showed that 99.95% of the weld length were accepted and the hydrostatic test was accepted at the first attempt. The Figure 2 shows the photo of the spiral case during the improvement programme.

Figure 2 The spiral case of Edevu hydropower plant during the improvement programme.
